Debris/Ice/TPS Assessment and Integrated Photographic Analysis for Shuttle Mission STS-57

July 1993

Gregory N. Katnik
NASA/Kennedy Space Center

DEBRIS/ICE/TPS ASSESSMENT
AND
PHOTOGRAPHIC ANALYSIS
OF
SHUTTLE MISSION STS-57

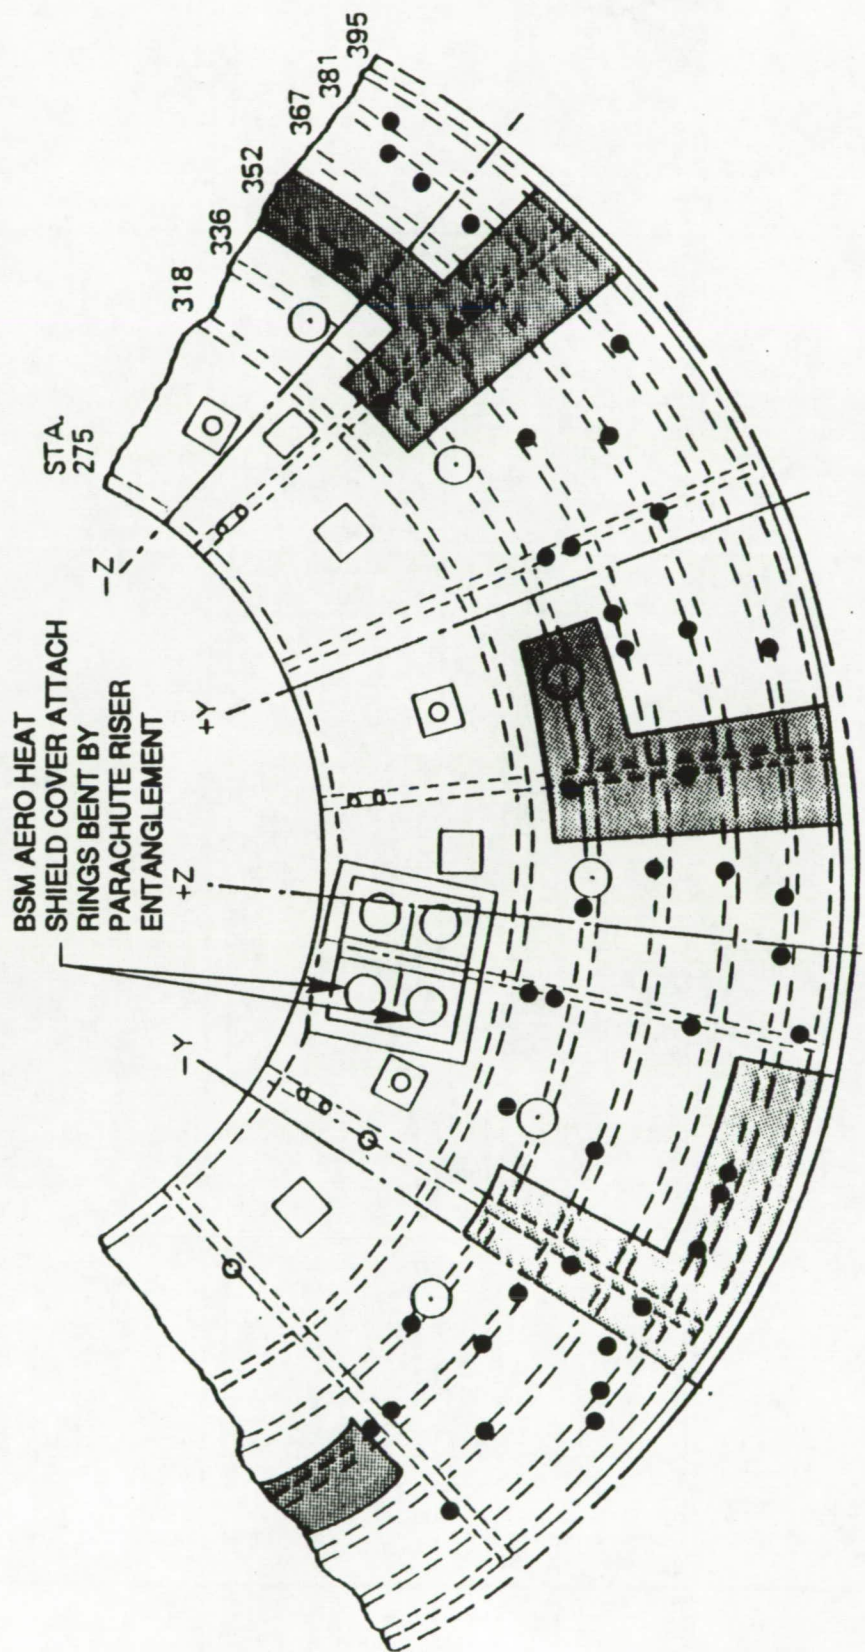
FIGURE 5. RIGHT SRB FRUSTUM

The RH frustum had 46 MSA-2 debonds over fasteners and two areas of missing MSA-2 (between the 275 and 318 ring frames near the -Y axis). Minor blistering of the Hypalon paint had occurred in localized areas (Figure 5). All BSM aero heat shield covers were locked in the fully opened position, though the two left cover attach rings had been bent by parachute riser entanglement.

MISSING TPS
2 0

DEBONDS
46 ●

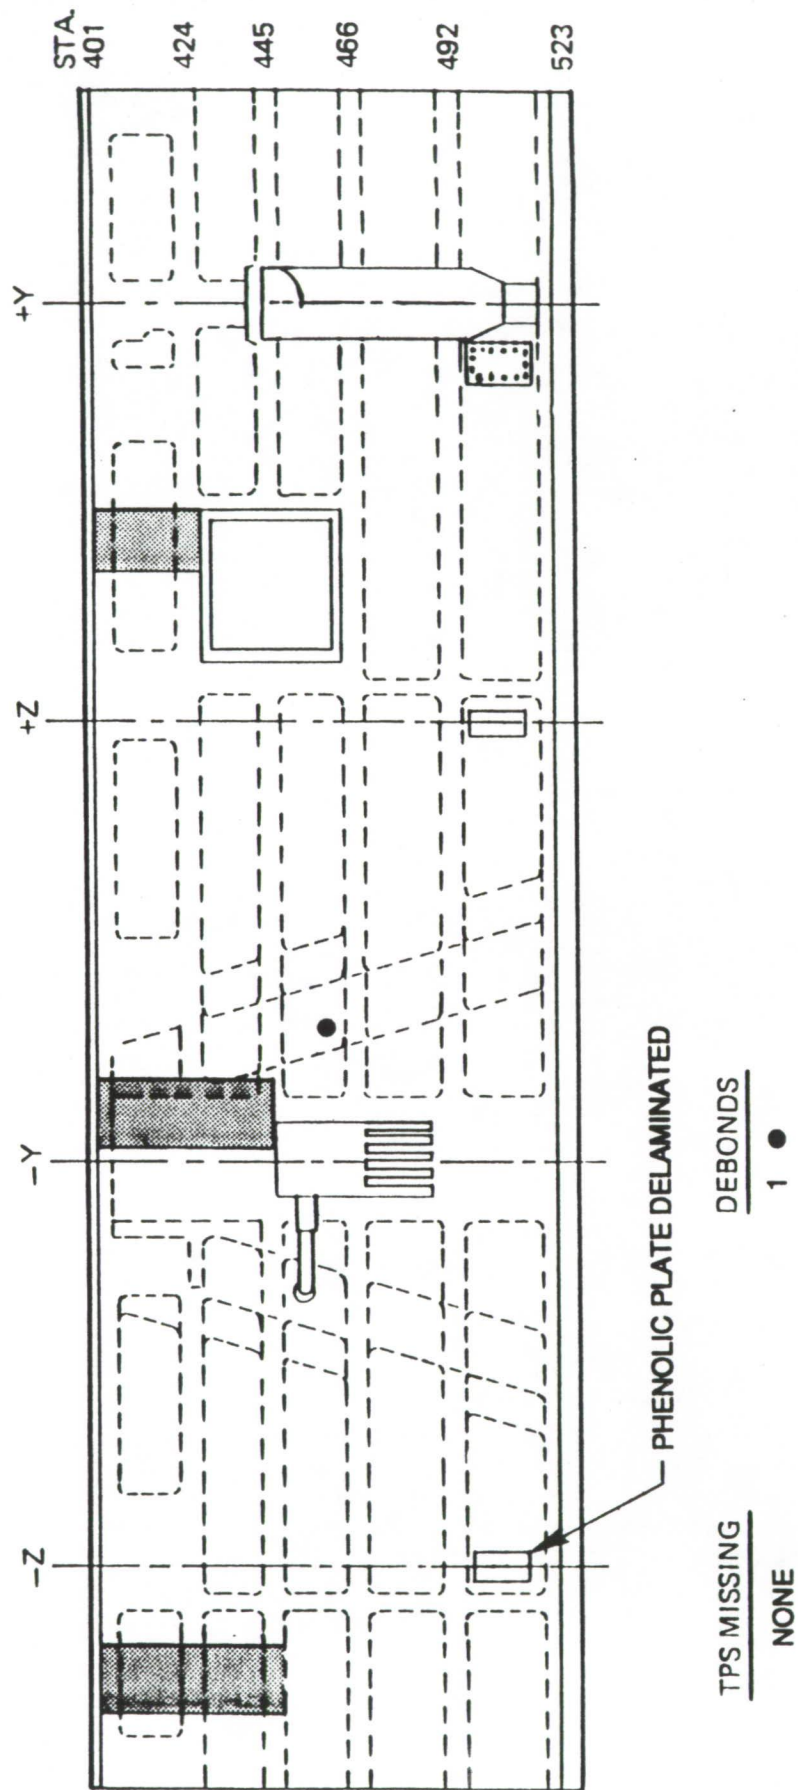
FIGURE 6. RIGHT SRIB FWD SKIRT

The RH forward skirt acreage was missing no TPS, but had one MSA-2 debond near the forward attach fitting. Both RSS antennae covers/phenolic base plates were intact though the -Z plate had delaminated (Figure 6). Minor blistering of the Hypalon paint occurred on the systems tunnel cover and around the ET/SRB attach point. No pins were missing from the frustum severance ring. The forward separation bolt appeared to have separated cleanly.

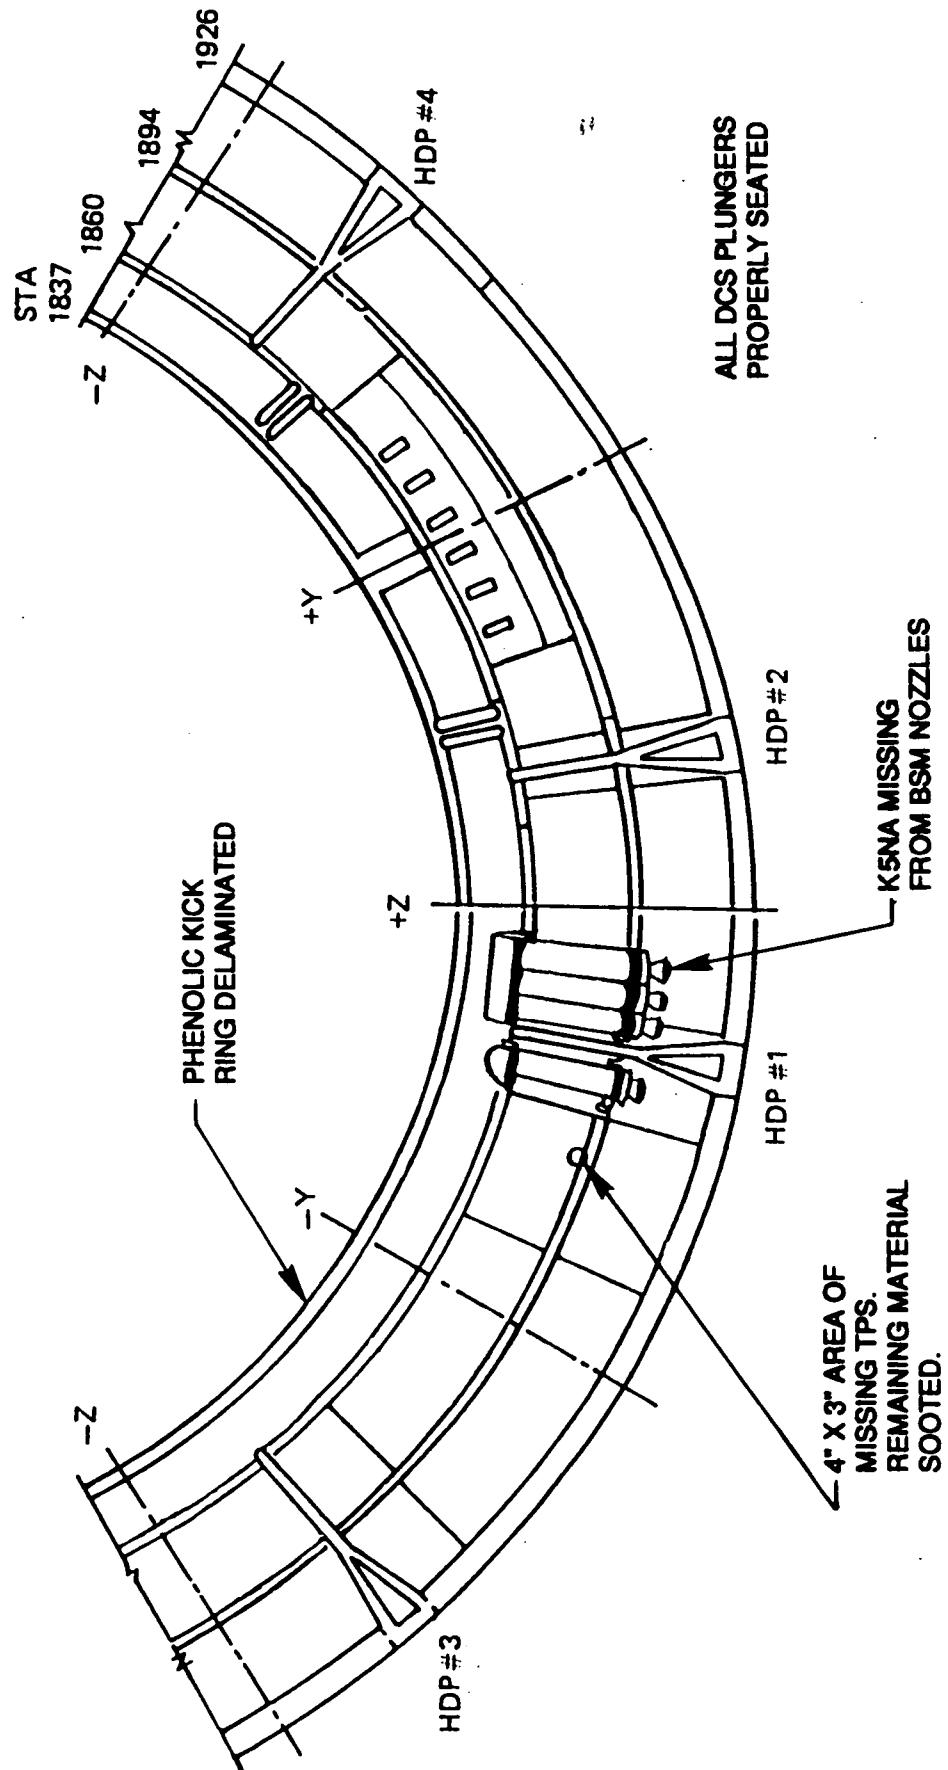
FIGURE 7. RIGHT SRB AFT SKIRT EXTERIOR TPS

The phenolic material on the kick ring was delaminated. The K5NA closeouts (protective domes) on the kick ring forward and aft fasteners are no longer used. RTV-133 has replaced the K5NA over the forward fasteners. The aft skirt acreage TPS was generally in good condition but was missing a 4"x3" piece of MSA-2 on ring frame 1894 fasteners near the single BSM (Figure 7).

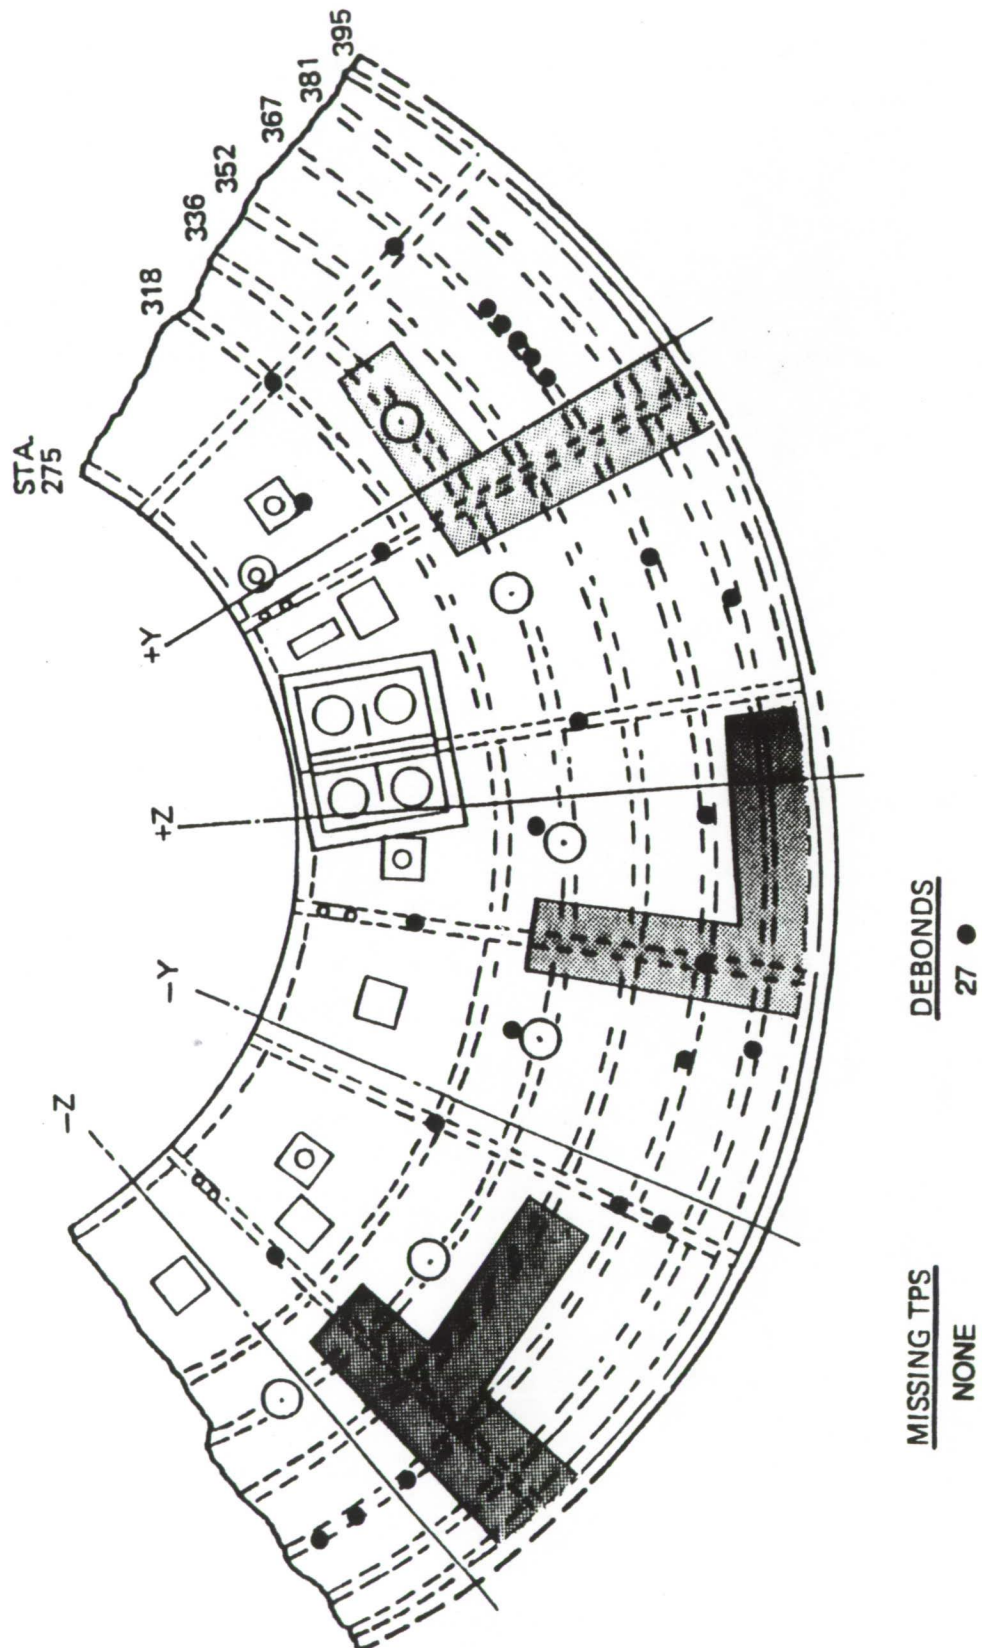
FIGURE 8. LEFT SRB FRUSTUM

The LH frustum was missing no TPS, but had 27 MSA-2 debonds over fasteners. Minor localized blistering of the Hypalon paint had occurred along the 395 ring (Figure 8). The BSM aero heat shield covers were locked in the fully opened position.

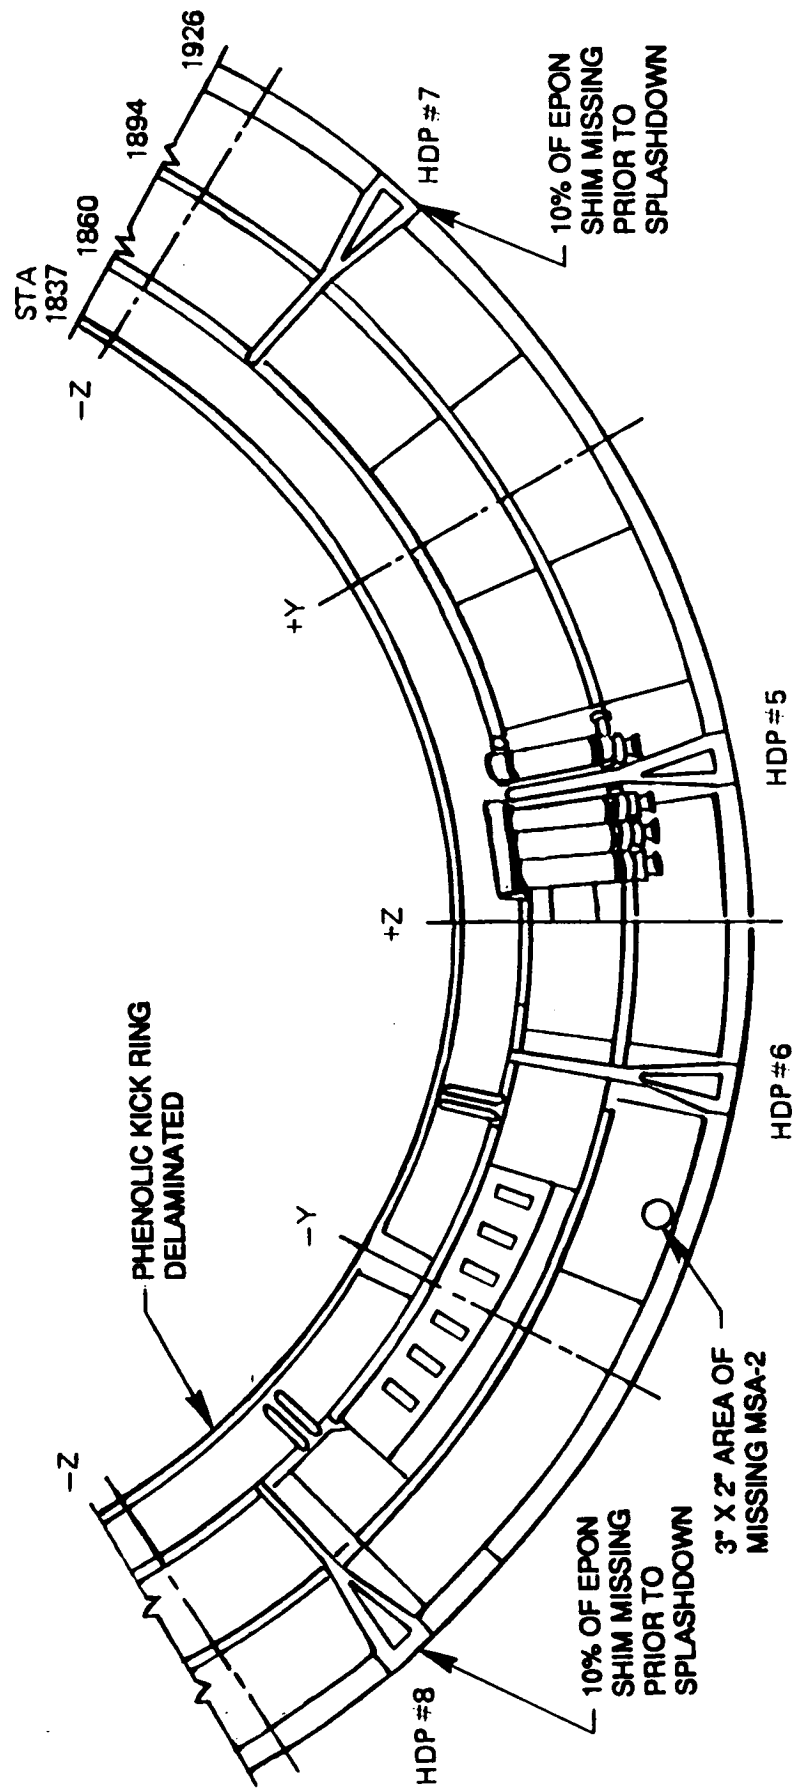
FIGURE 9. LEFT SRB AFT SKIRT EXTERIOR TPS

The phenolic material on the kick ring was delaminated. The K5NA closeouts (protective domes) on the kick ring forward and aft fasteners are no longer used. RTV-133 has replaced the K5NA over the forward fasteners. One 3"x2" area of MSA-2 was missing from the aft skirt acreage TPS near the 1926 ring frame between the -Y and +Z axes. The remaining material was slightly sooted (Figure 9).

ALL DCS PLUNGERS
PROPERLY SEATED

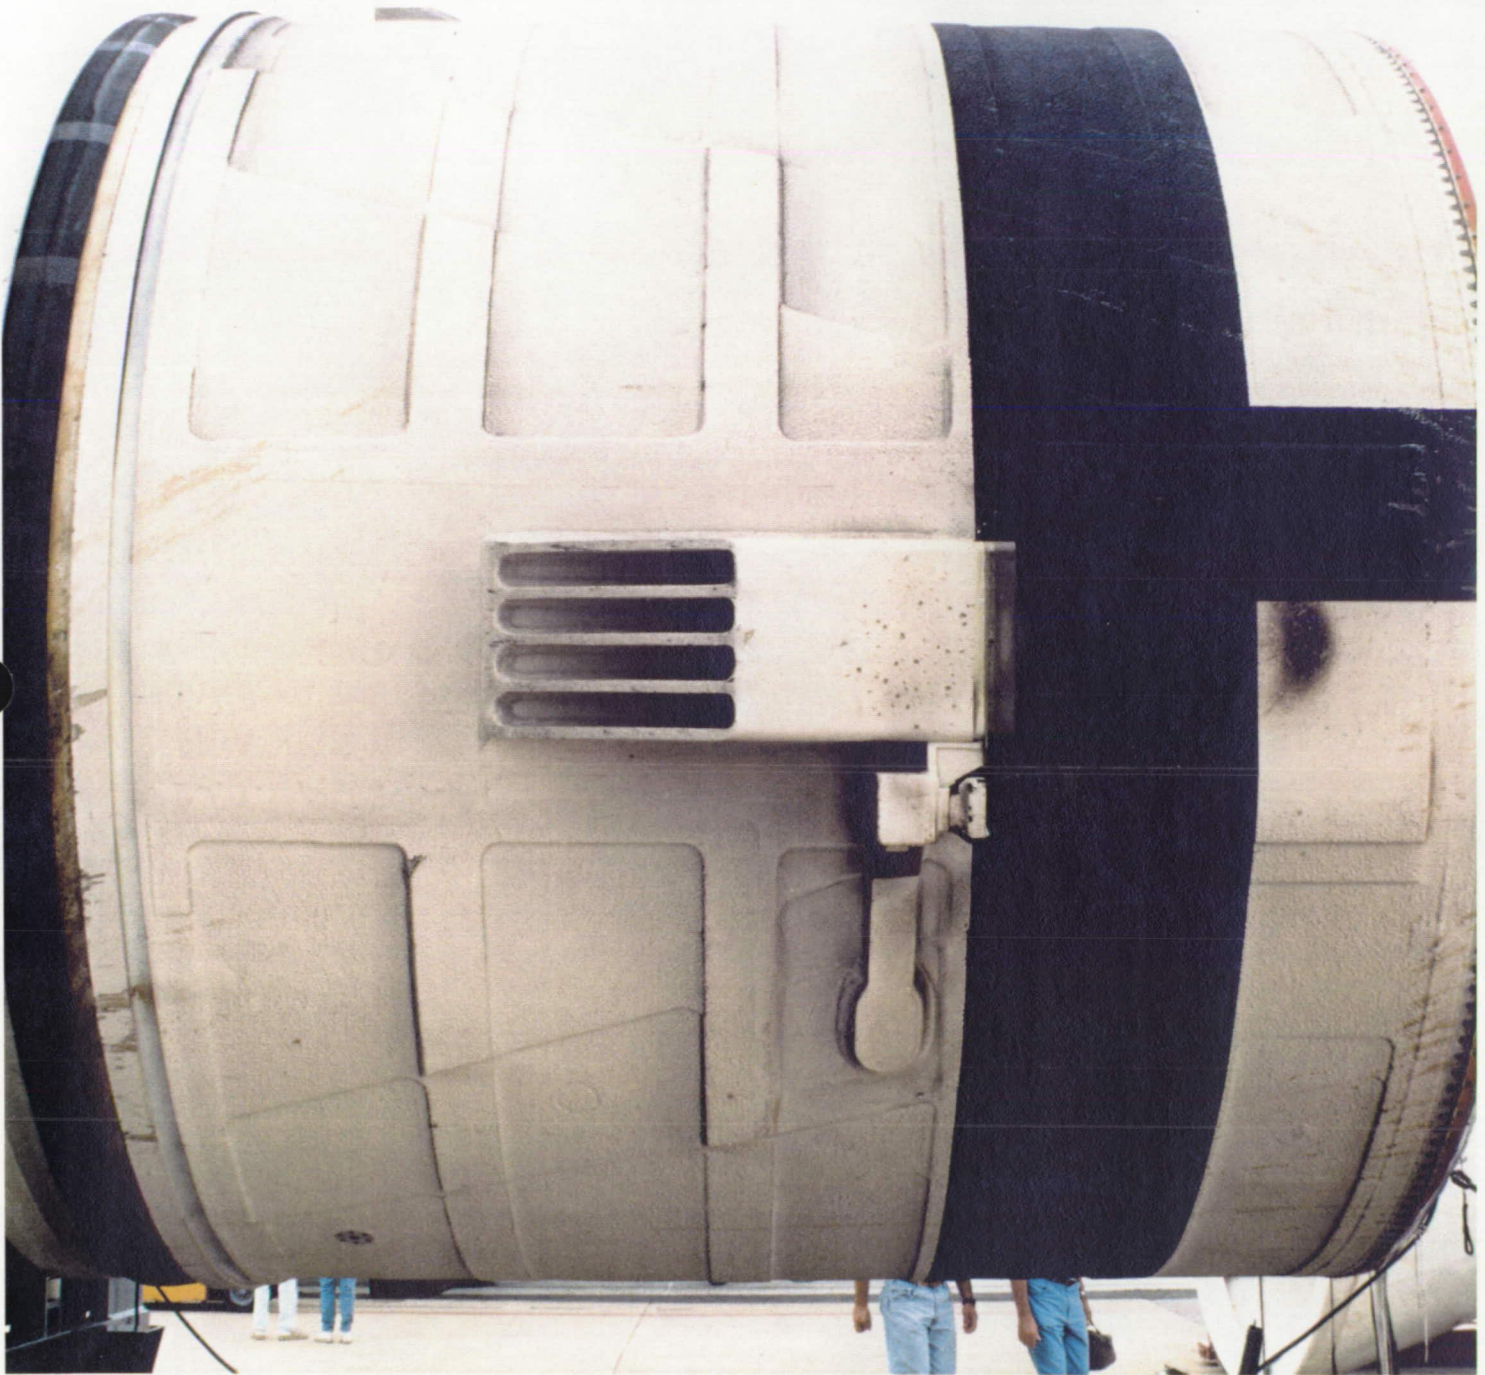
The LH frustum had a total of 27 MSA-2 debonds over fasteners. The BSM aero heat shield covers were locked in the fully opened position.

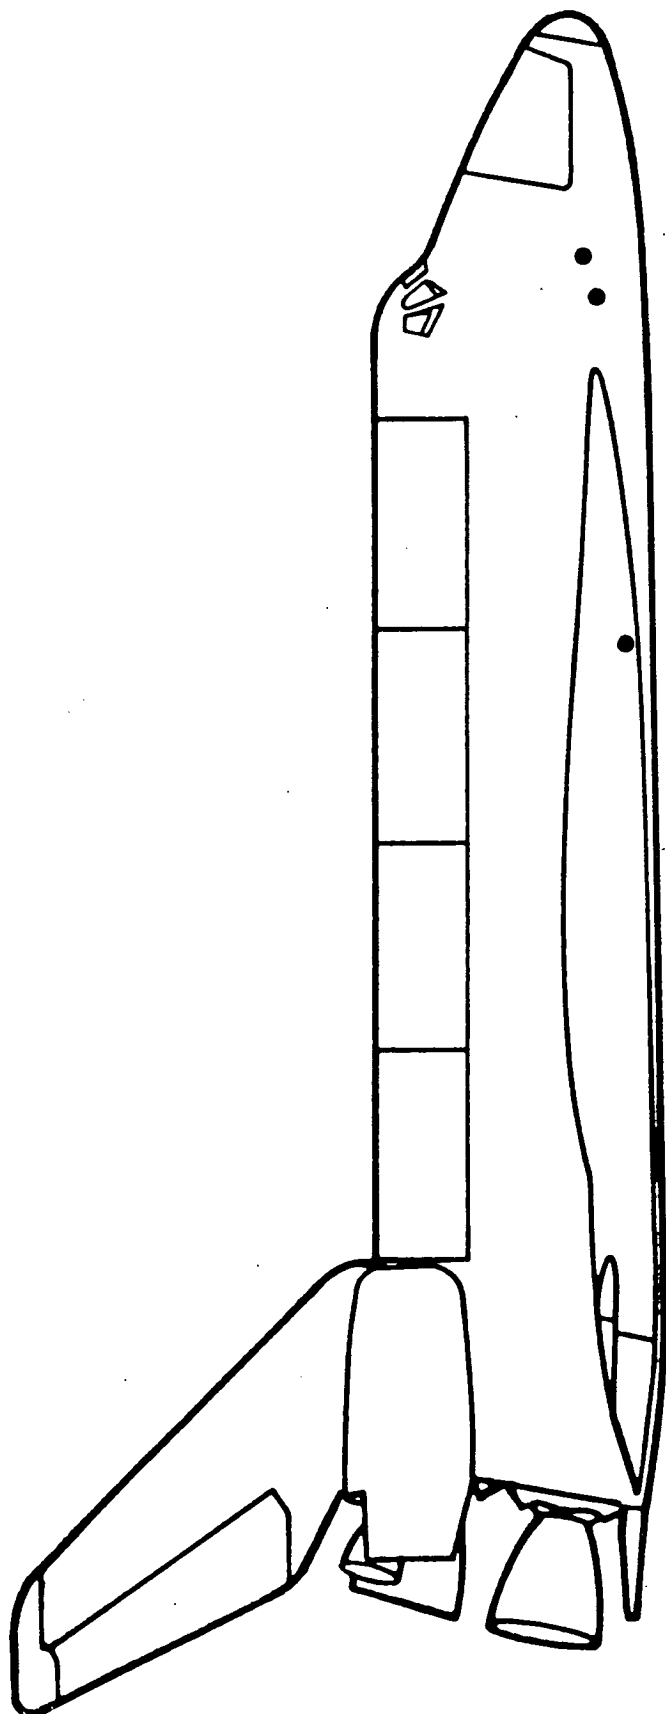
FIGURE 12
STS-57 **DEBRIS DAMAGE LOCATIONS**

TOTAL HITS = 3
HITS > 1 INCH = 0

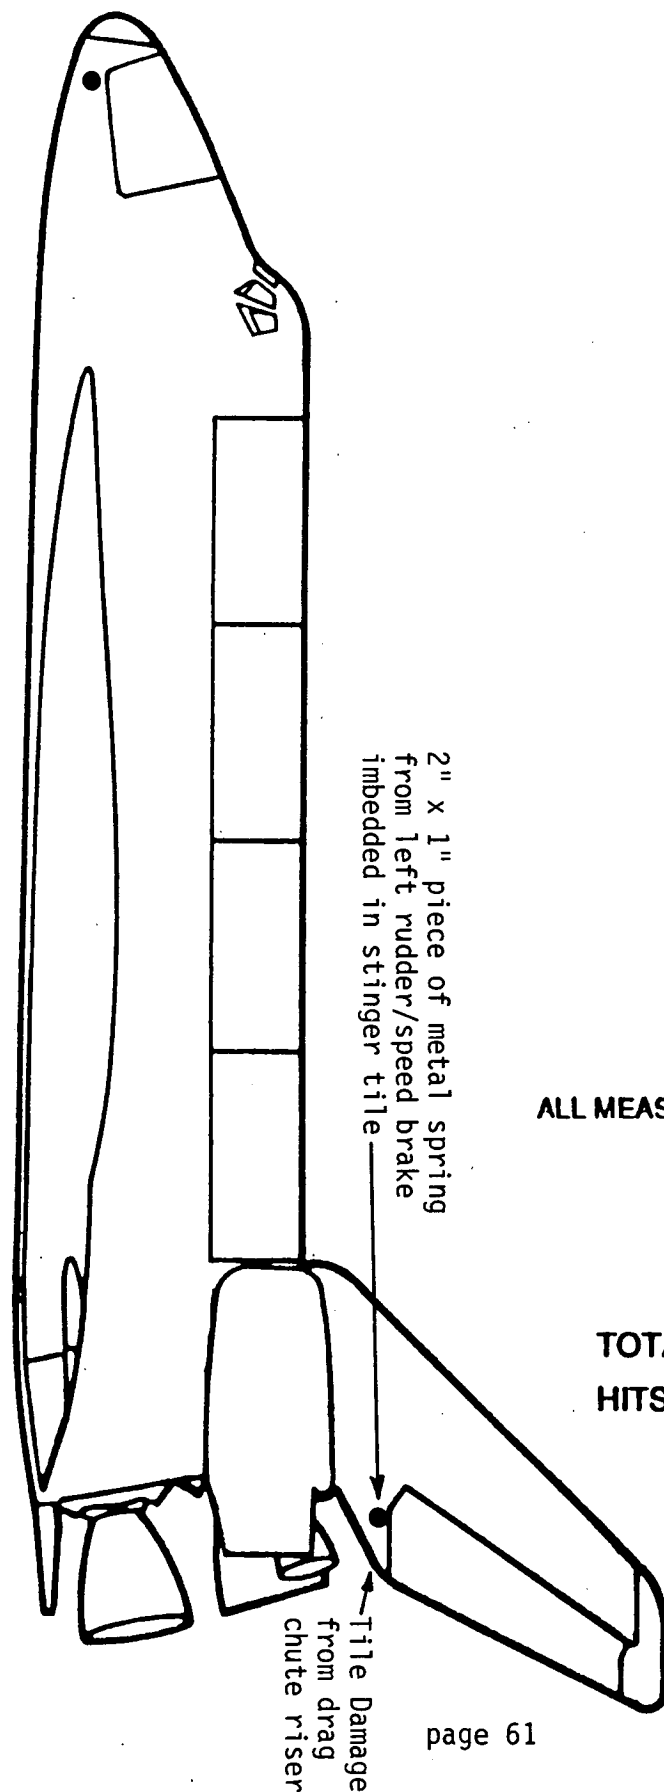
FIGURE 13

TOTAL HITS = 2
HITS > 1 INCH = 1

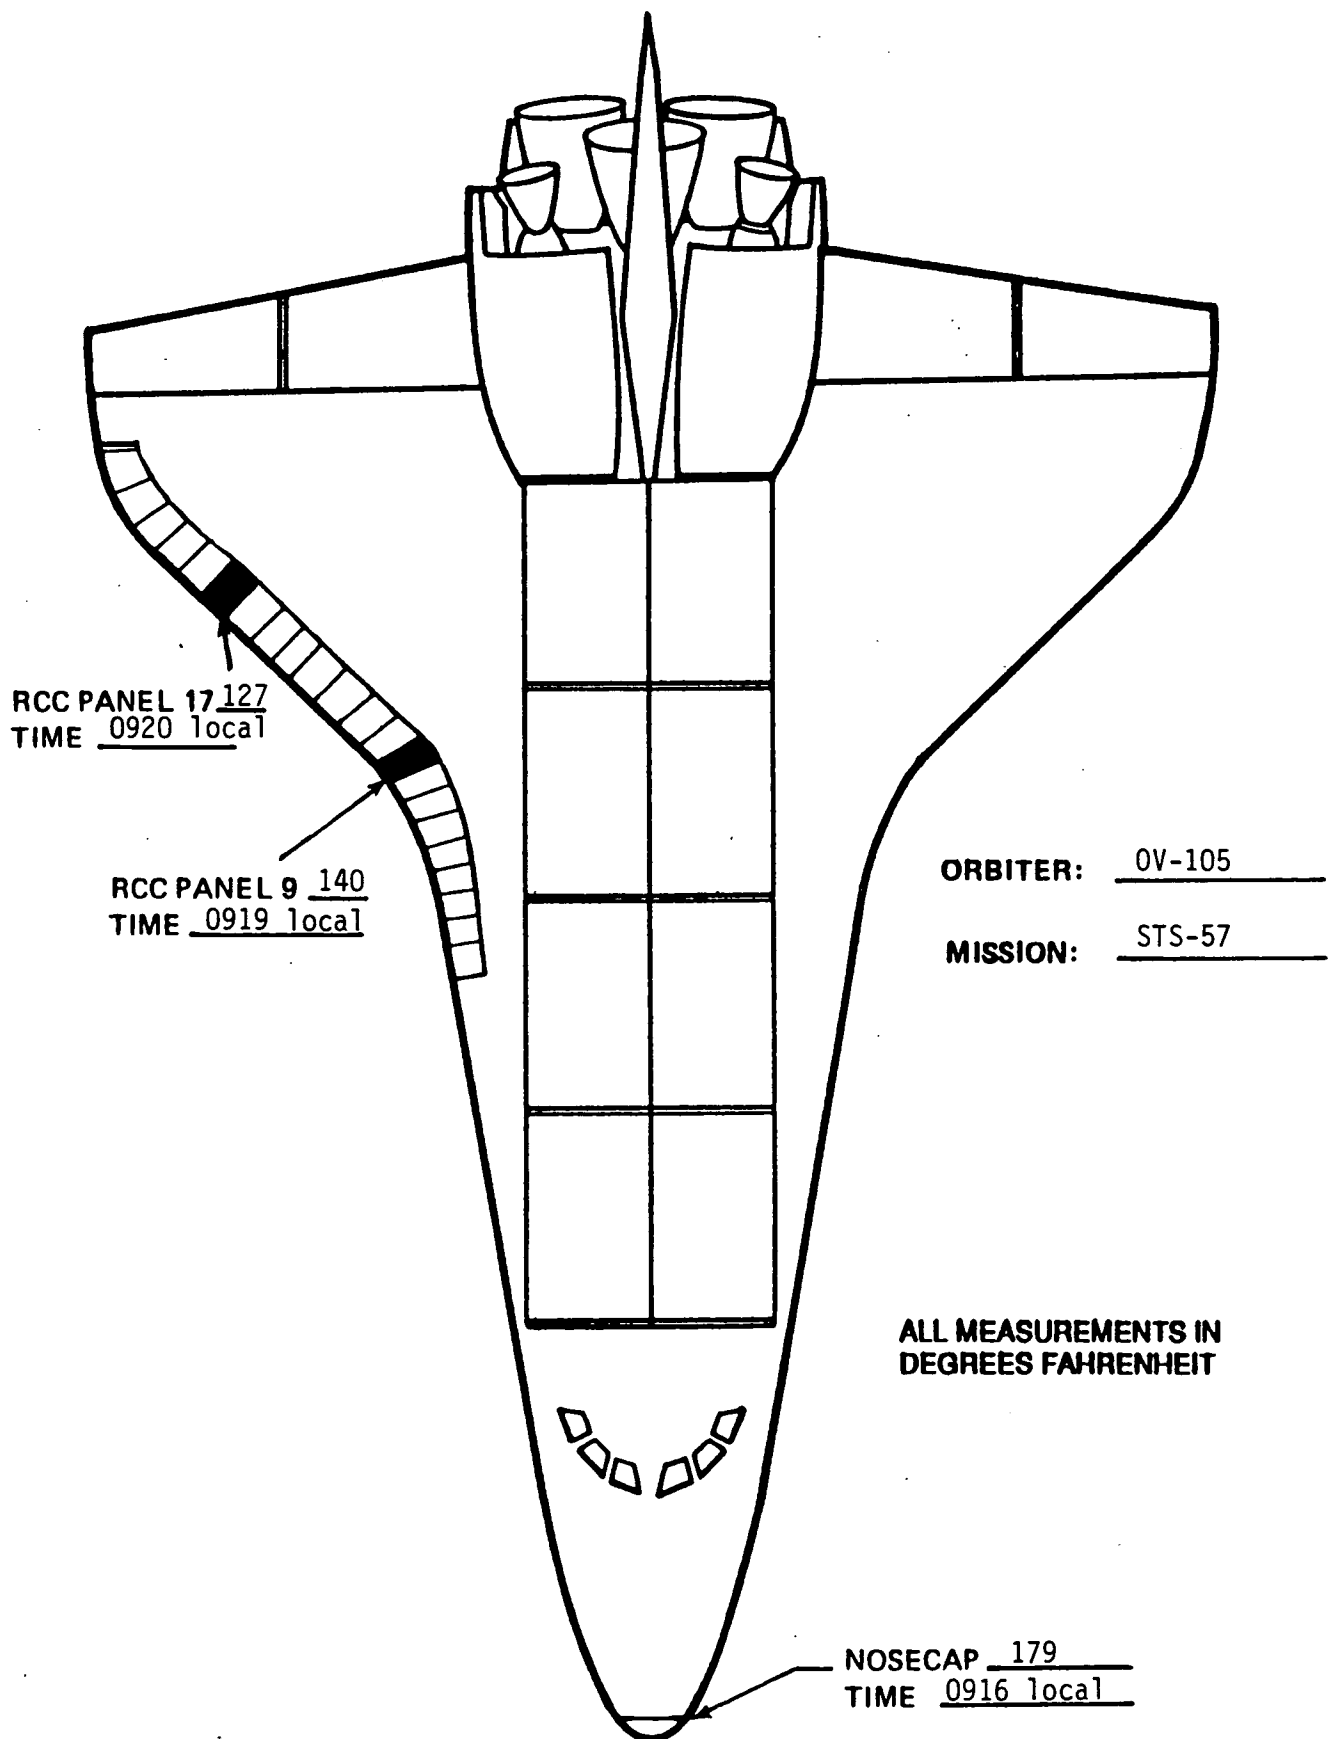
FIGURE 14. **STS-57 RCC TEMPERATURE MEASUREMENTS AS
RECORDED BY THE SHUTTLE THERMAL IMAGER**

The Shuttle Thermal Imager (STI) was used to measure the surface temperatures of several areas on the vehicle (per OMRSD V09AJ0.095). Twenty-one minutes after landing, the Orbiter nose cap RCC was 179 degrees F. Twenty-four minutes after landing, the RH wing leading edge RCC panel #9 was 140 degrees and panel #17 was 127 degrees F (reference Figure 14).

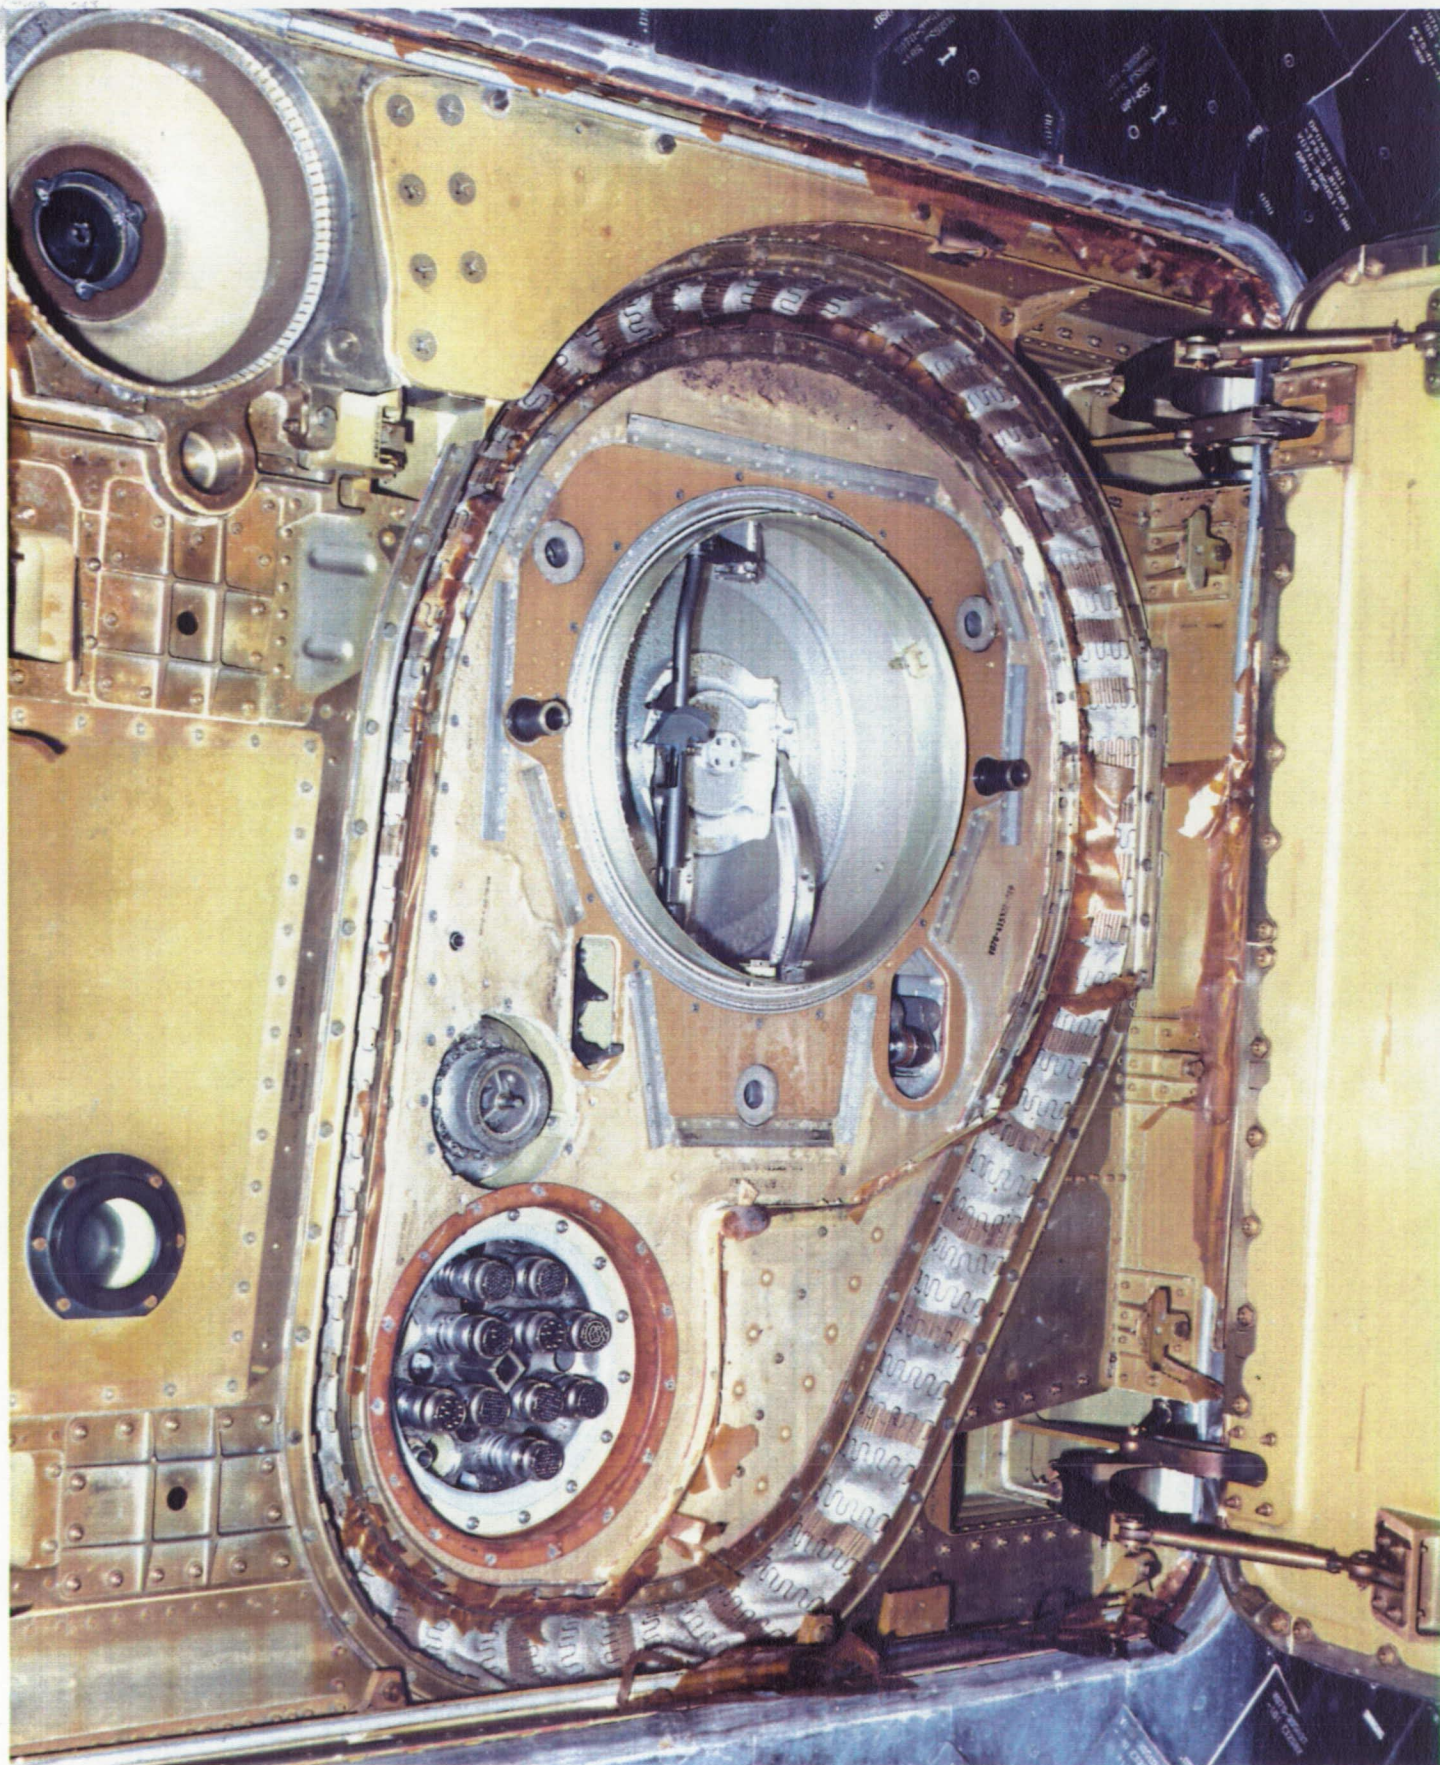
Overall view of the L02 ET/ORB umbilical. All separation ordnance devices functioned properly. No flight hardware was found on the runway below the umbilical when the ET door was opened.

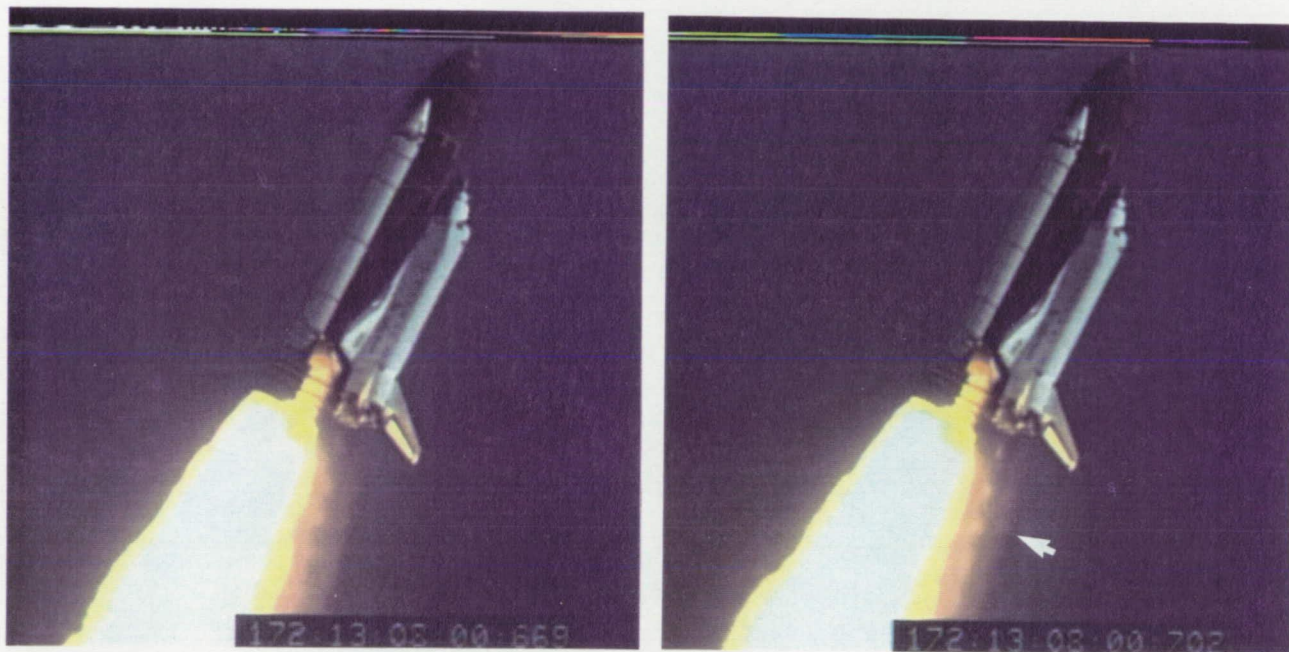
Light Colored Streak in SSME plume at 38 seconds MET and Reference Image

A light colored streak was noted in the SSME plume at approximately 38 seconds MET on ET-212. Figure 2.3.2 provides an image of the streak along with an image of an earlier time without the streak. A white puff (believed to be the same event seen from a different perspective) was noted at the same time and similar position on camera ET-204.

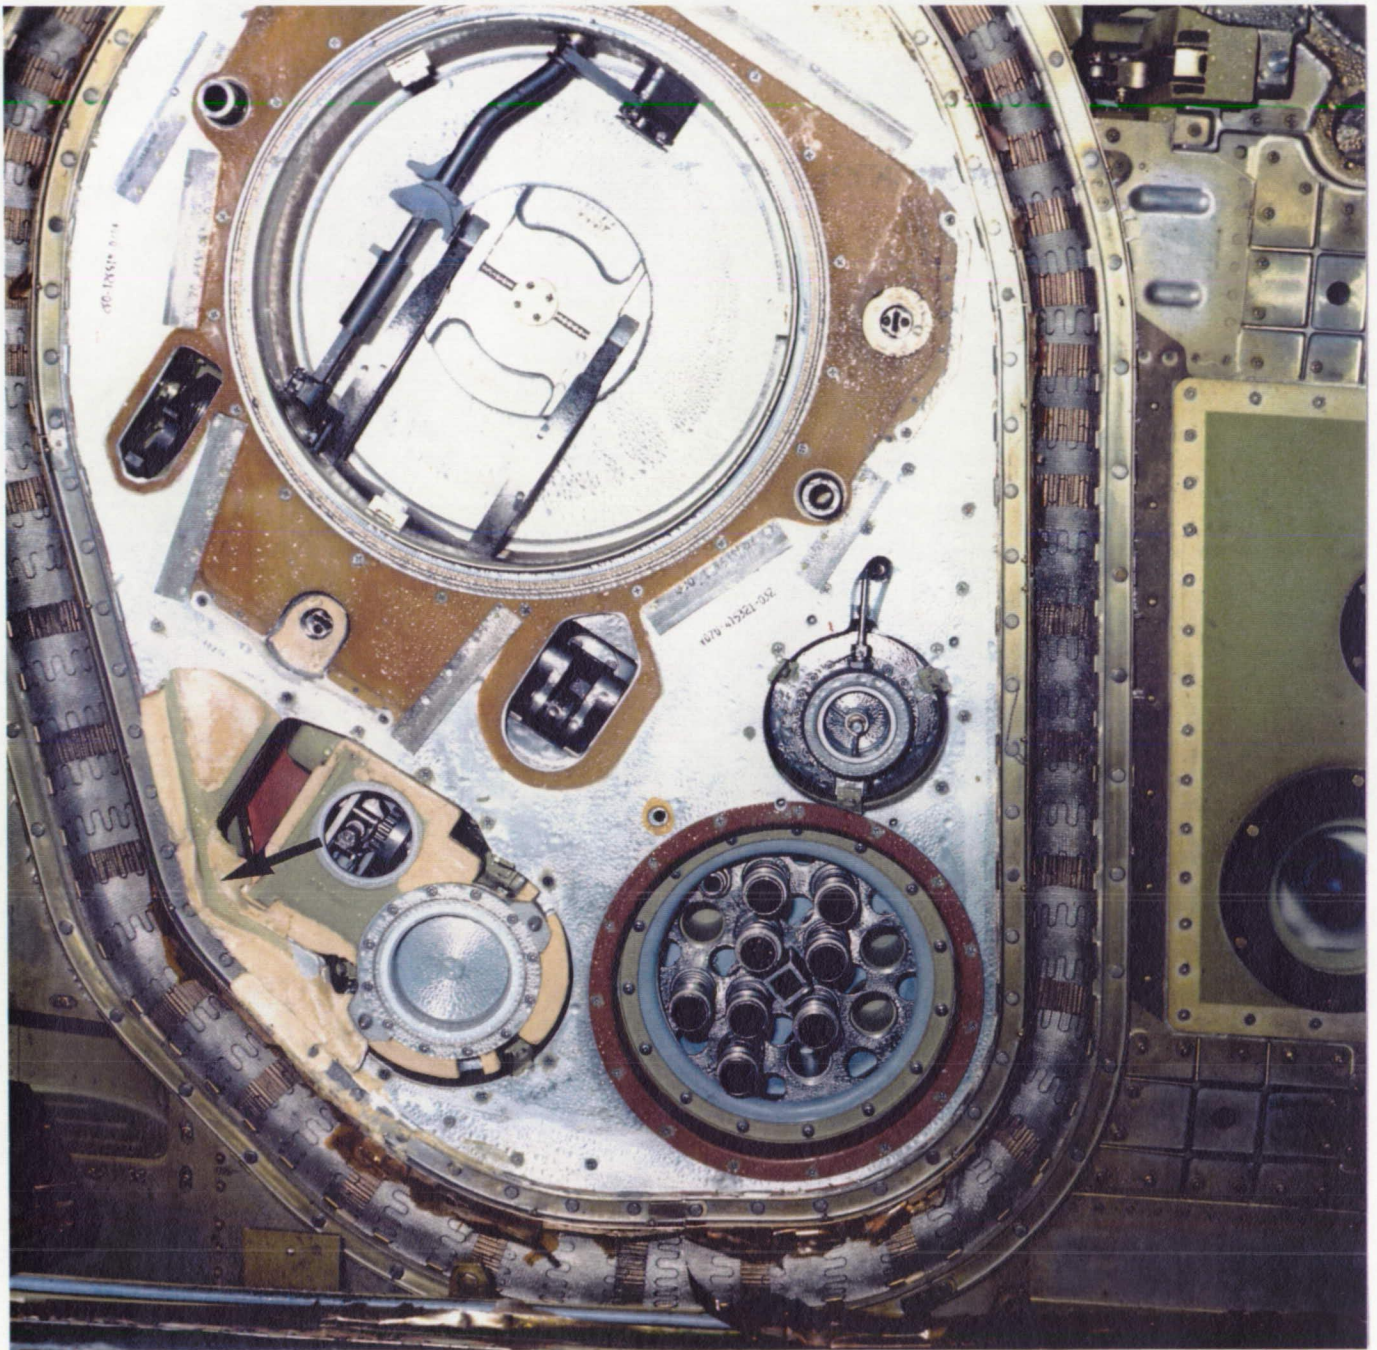
Figure 2.4.3b Closeout Picture of the LH2 Umbilical taken by the KSC Debris Team

A picture of the Orbiter LH2 umbilical (Figure 2.4.3b) taken by the KSC Debris Team after landing indicated that approximately 10 inches of foam material remained near the four inch line connect. The 16 mm umbilical well camera film of the ET LH2 anomalies was shown to the JSC Propulsion and Power Division/EP2 engineers. The JSC engineers suggested that the closeout foam placed near the four inch line connect prior to launch

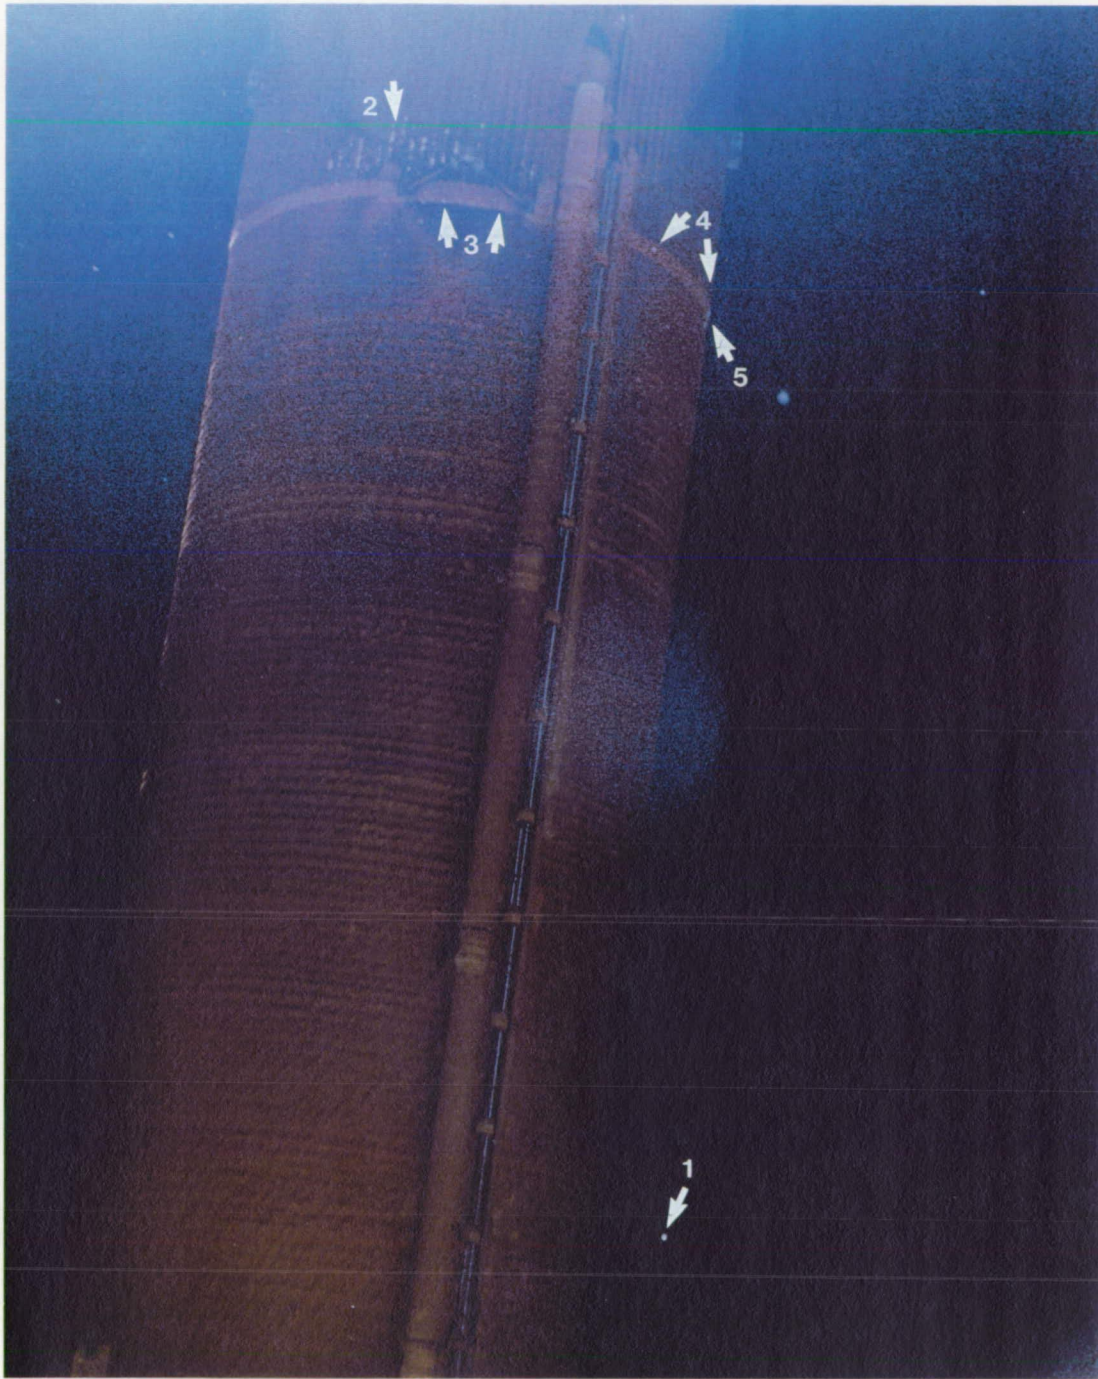
**Figure 2.4.4b****35 mm Camera View of the Bipod and LH2
Tank/Intertank Region of the External Tank**

Multiple pieces of white debris were imaged between the camera and the external tank. The white debris appeared to be ice (1). Multiple white "popcorn" marks were visible on the intertank stringers forward of the bipod (2). Several small white marks or divots were visible between the bipod legs on the LH2 tank/intertank closeout flange (3). Two divots less than six inches in size were visible on the intertank closeout flange to the right of the
